Axial Capacity of Corrosion-Damaged Circular Columns Wrapped with FRP Composites

Abstract: This Paper described an experimental study that evaluate the axial capacity of circle column damaged due to chlorination. Fiber-reinforced composite sheets are ideal products to be used as jacketing systems for under designed or damaged reinforced concrete columns that could benefit from confinement of the concrete core. This technology has found two different fields of application in repair and strengthening of existing reinforced concrete columns and bridge piers: 1. Repair and upgrading for earthquake resistance; and 2. Repair of corrosion-damaged members where the transverse and even the longitudinal reinforcement are no longer dependable. The process called half-cell oxidation reaction or response anodic reaction is use to create chlorination process in lab and took result. The result shows that On the average to discuss it clear that concrete after corrosion losses its strength up to an average 23% and after repaired by CFRP it overall strength increase to 51%. In which 23% gain and 23% additional strengthening. It is recommended that jacketing with different material such as fiber-rei

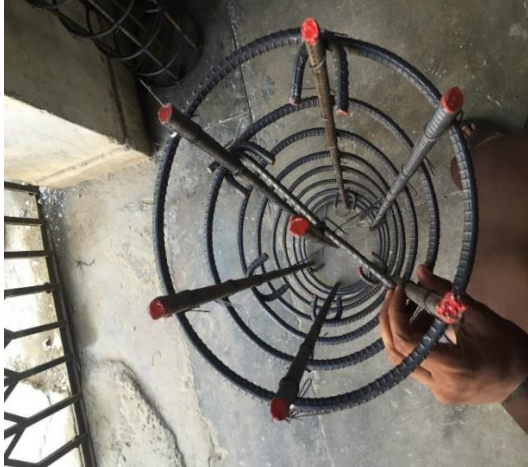
Fig 3.1: Reinforcement Cage

Seven cylindrical column specimens (03 no. Reference (Undamaged) "B", 04 No. Corroded (Damaged) "C" after repaired with CFRP 04 no. Type "C" converted to Corroded Repaired (Damaged Repaired) "CR") were cast with dimensions 302 mm in diameter by 1200 mm in height and reinforced with three 13M (13M = 12.7 mm nominal diameter) longitudinal steel bars at 12.7 mm cover have Grade 40 (Fig. 3.1).

In past last 20-25 year, back the nominal steel ration for typical bridge design were taken $\rho_s = 1.7\%$ which is confidentially used in simple underpasses and flyovers throughout the Pakistan, the specimen used in the research is 1/3 scale model of typical bridge piers the main steel/ longitudinal reinforce is connected to 12V DC source(Battery) and center bar along center line of test samples bar of 13M is to provide for cathode shown in (Fig. 3.1).

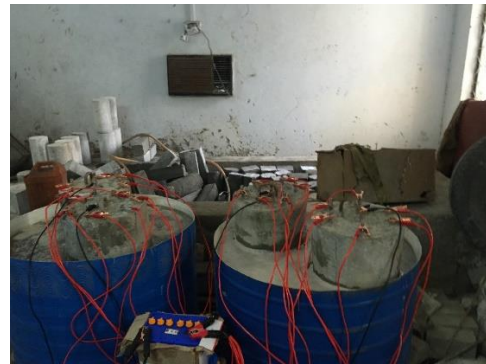
Fig 3.3: Chlorination Setup

To provide the same environment in lab electrochemical cell process is required which also accelerate the corrosion process as to took the experiment with n the study duration and a systematic study of corrosion process is also possible. For this a 12V DC power source (battery) is used, anode is connected to the 6-Nos main/longitudinal reinforcement bars and cathode is connected to a 13M bar place along the centerline of the sample for an electrochemical cell is established. Samples are placed in a plastic drum in the start of the process the container is filled up to $\frac{3}{4}$ height with 5% Cl_2 solution after one month level reduced to about 600mm container covered with the plastic sheets to provide more humid environment to accelerate the rate of corrosion.

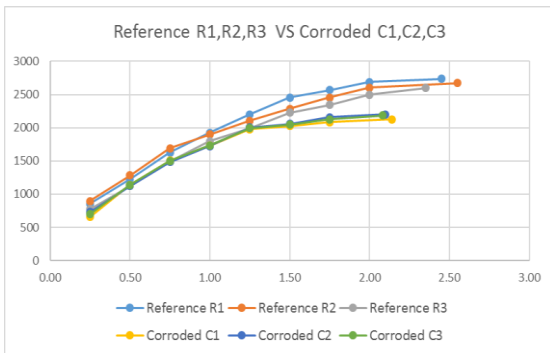
Fig 4.2: Comparison of R1, R2, R3 vs C1, C2, C3

Difference in axial capacity after corrosion is evident of loss of strength maximum to 610 KN (22% reduced) and on an average of 499.7 KN (19 % reduced) which shows how dangerous it is. Also compared in bar graph below:

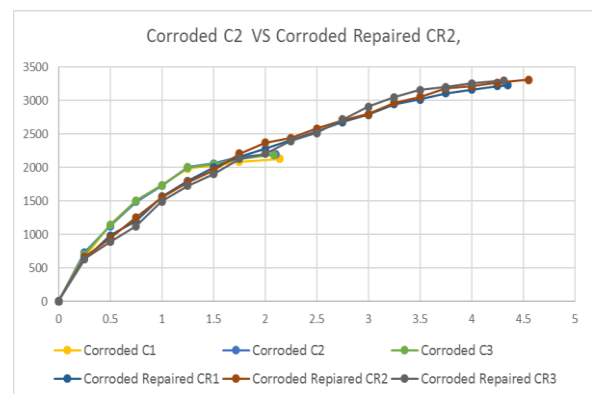
Fig 4.2: Comparison of C1, C2, C3 vs CR1, CR2, CR3

Difference in axial capacity after repaired by CFRP it is evident of increase in strength maximum to 1113 KN (51% increased) and on an average of 1107 KN (51 % reduced) which shows that damaged sample regain its strength as well as there is also about 23% strengthening as well. Also, compared in bar graph below:

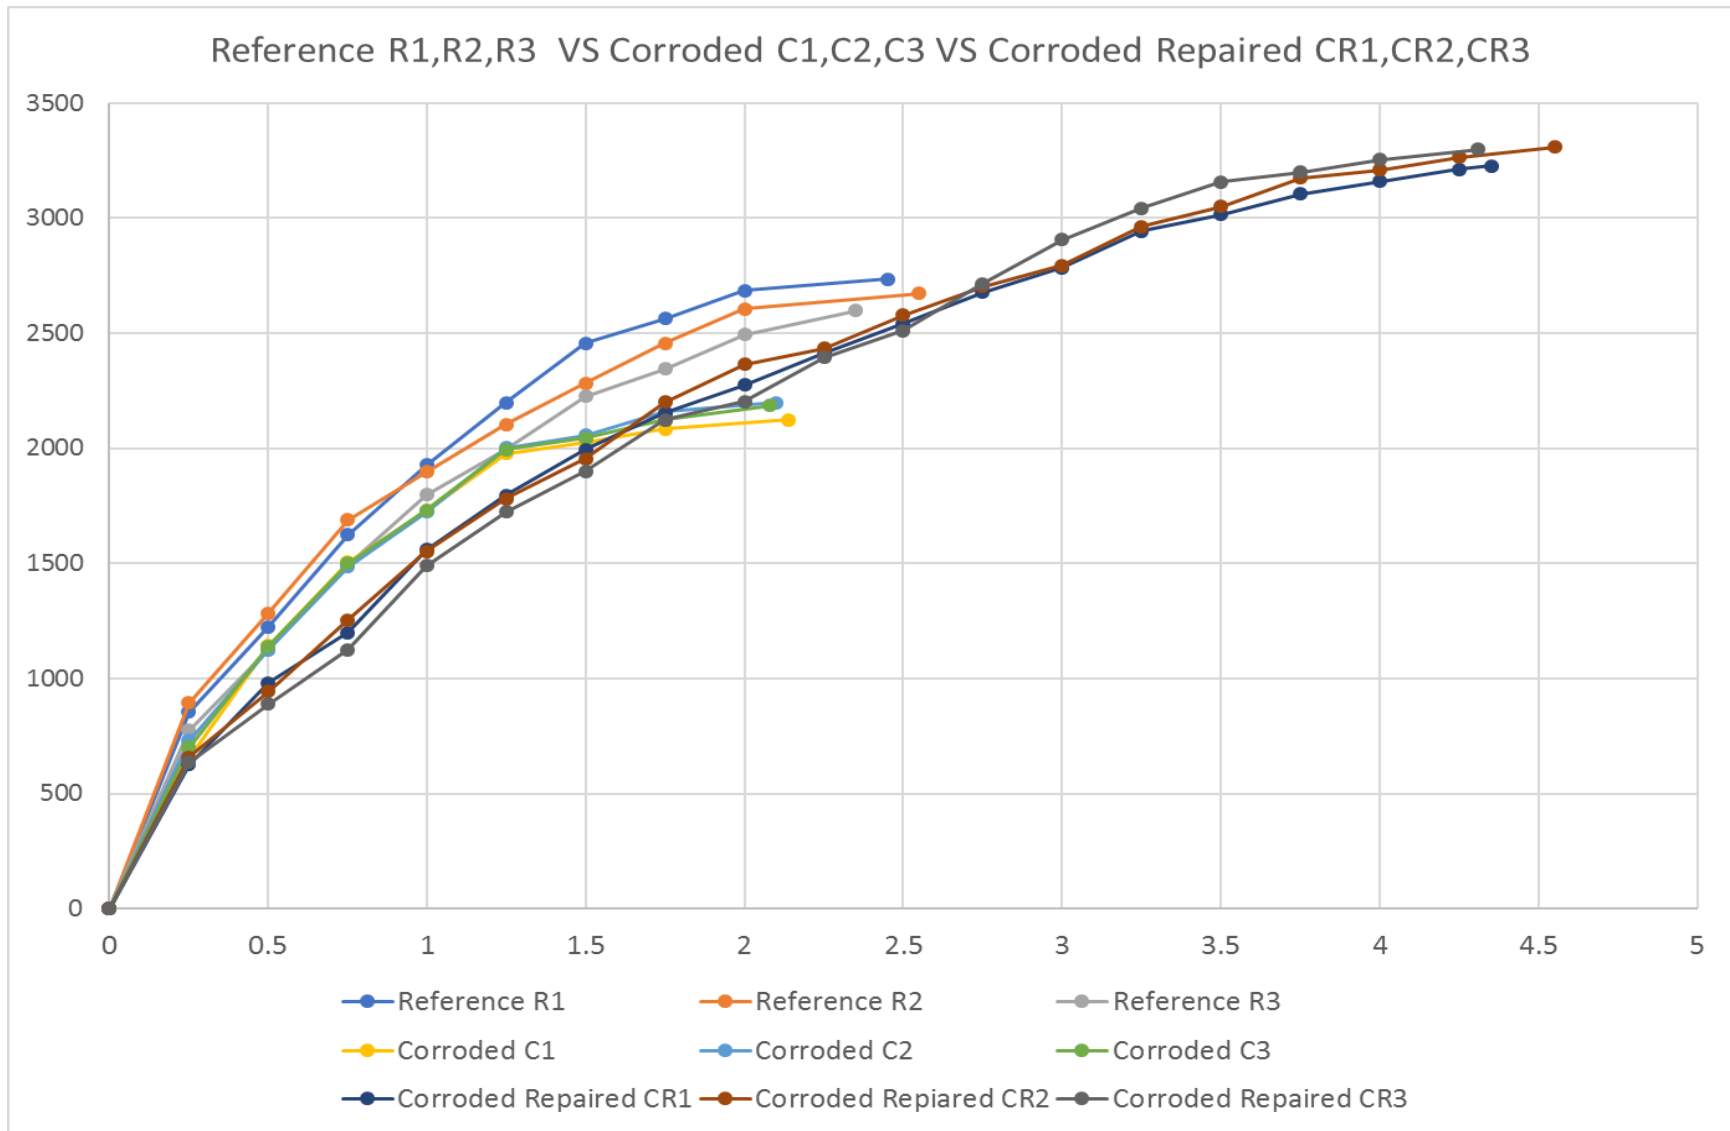
Fig 4.4: Comparison of R1,R2,R3 vs C1,C2,C3 vs CR1,CR2,CR3

As we discuss column no. 01 its shows that after corrosion there was 18% reduction in strength and after repaired by CFRP it gains its strength as well as there are 18% additional increase strength form the original (Reference strength) and it also shows their overall gain in strength increase 52% form the lowest strength (corroded)
As we discuss column no. 02 its shows that after corrosion there was 24% reduction in strength and after repaired by CFRP it gains its strength as well as there are 24% additional increase strength form the original (Reference strength) and it also shows their overall gain in strength increase 51% form the lowest strength (corroded)

As we discuss column no. 03 its shows that after corrosion there was 27% reduction in strength and after repaired by CFRP it gains its strength as well as there are 2% additional increase strength form the original (Reference strength) and it also shows their overall gain in strength increase 51% form the lowest strength (corroded)
