ANALYZING BARRIERS TO UNIVERSAL ACCESSIBILITY IN CITY CENTRE, PUNE

Amruta Kakirde*¹, Prof. Dr. Gouri Desai²

¹ Research Scholar, Ajeenkya D Y Patil University, Pune.
amruta.kakirde@adypu.edu.in

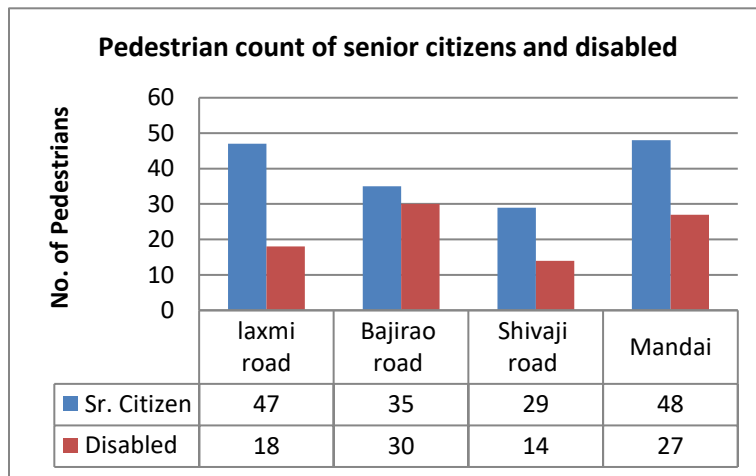
Figure 2 Pedestrian count of senior citizens and disabled (Source- Primary Survey)

The figure 4 shows the total number of senior citizens and disabled citizens walking on the selected streets in the study area. We have already seen listed obstacles faced by pedestrians. Figures in the bargraph show substantial count of senior citizens and disabled. The situation insists on provision for universal accessibility design to be implemented on busy streets of Pune.

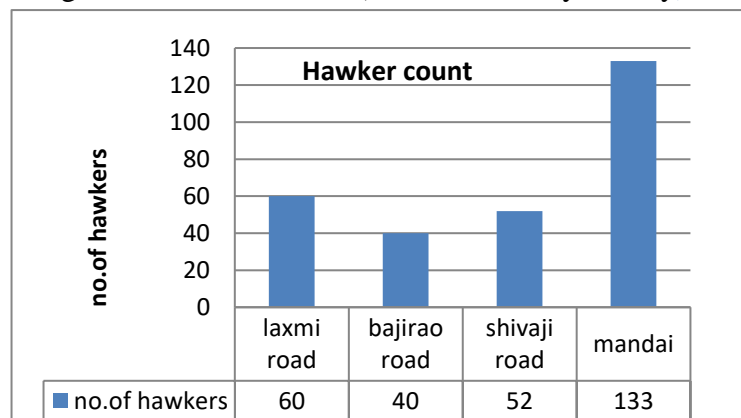
Figure 3- Hawker Count (Source- Primary Survey)

The hawkers count was taken on all four streets of study area on different days. These counts were taken for whole day and the maximum count of hawkers per day has been presented in the graph below. Maximum hawkers count was taken at Mandai and lowest on Bajirao road.

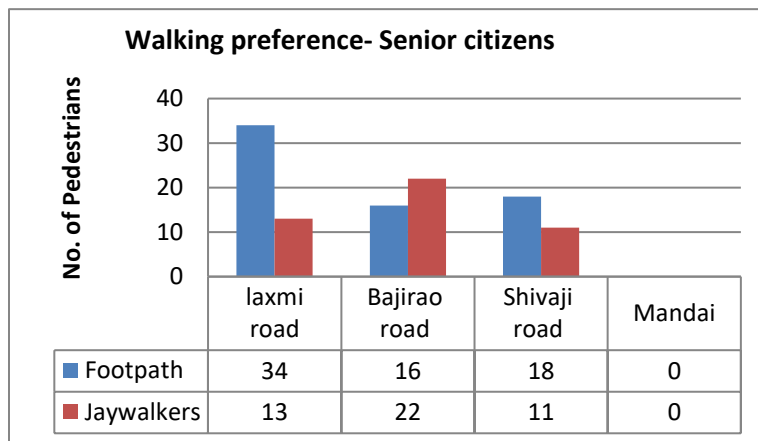
Figure 4 - Walking Preference- Senior Citizen (Source- Primary Survey)

The figure 3 shows the walking preference of senior citizens on and off the footpath. Some senior citizens walk off the footpath (Jay walkers) because of unsafe pedestrian path, encroachment, congestion and other obstacles on the footpath. More footfall of senior citizens is observed in Mandai for vegetable purchasing. The Mandai area does have footpath but it is not for the purpose of pedestrian use. These pedestrian path are fully occupied by hawkers and vendors which is the main reason for jaywalking of senior citizens.

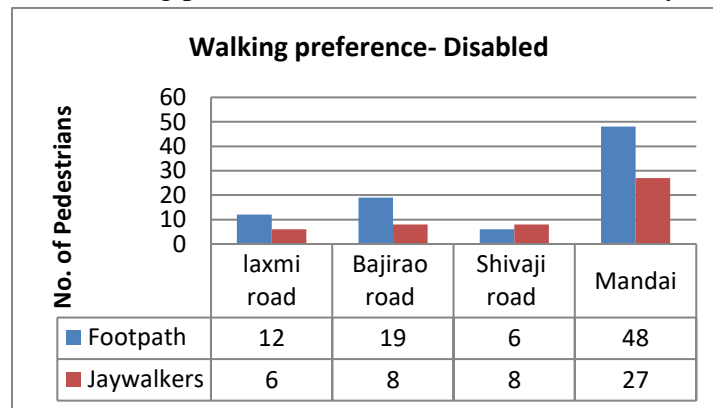
Figure 5 Walking preference- Disabled (Source- Primary Survey)

The figure 5 shows walking preference of disabled on and off the footpath in study area. Due to obstacles such as encroachment, parking, extension of shop, electric boxes Disable people are forced to walk from carriage way (Jay walkers) with moving traffic.

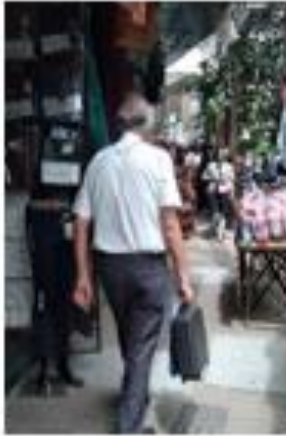
Photo 1 Sr. Citizen finding way through encroachment on footpath

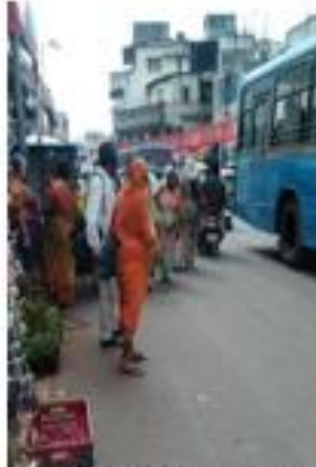
Photo 2 Jay walkers near Mandai

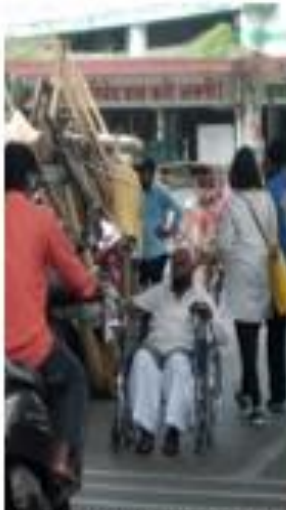
Photo 4 Disabled person on Wheelchair at Mandai

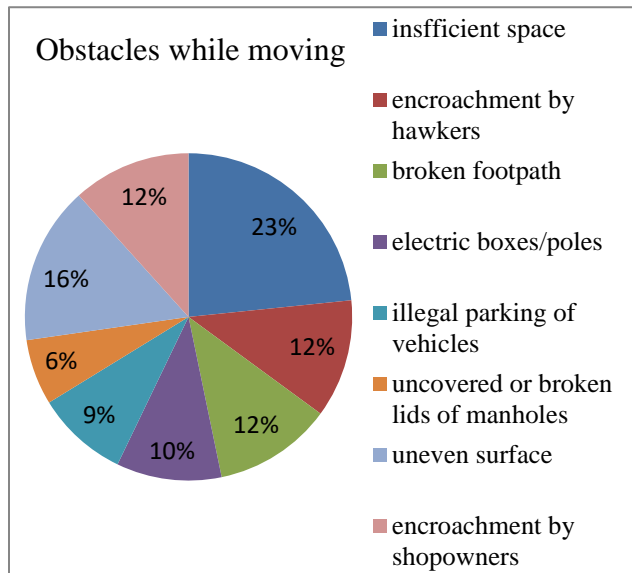
Figure 2 Obstacles faced by pedestrians while moving on Laxmi Road (Source- Primary Survey)

The graphs below show obstacles faced by pedestrians while mobilizing on laxmi road, Bajirao road, mandai and shivaji road. The major obstacles faced by pedestrians are presented in the photographs ahead.

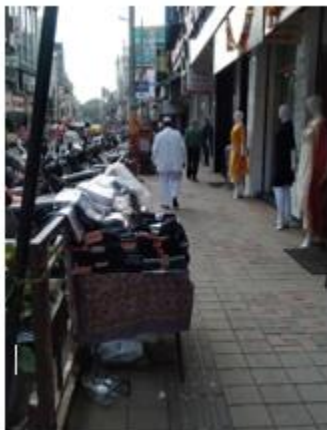
Photo 9 Encroachment by Hawkers

3.	Informal vending Encroachment	Informal Vendors are hindrance to pedestrian mobility. Encroachment is a policy failure. Illegally occupied spaces on the footpath create severe problems during peak hours.

Space	<ul style="list-style-type: none"> • Footpath width is increased by removing on street parking • Hawkers may be relocated which will increased pedestrian space.

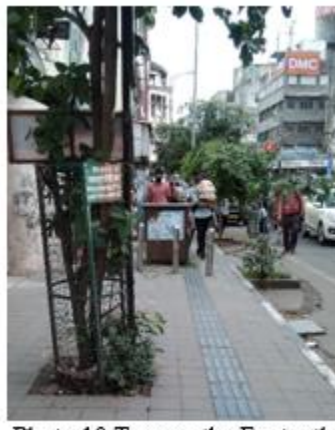
Photo 10 Tree on the Footpath

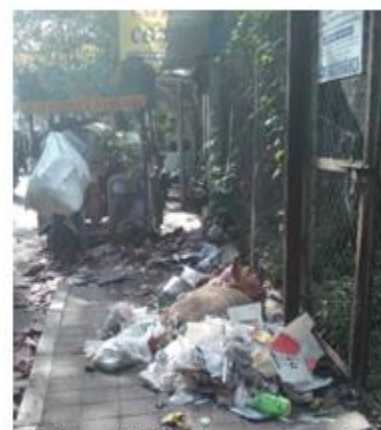
Photo 11 littering on footpath

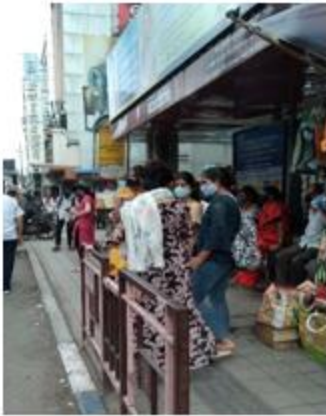
Photo 12 People waiting on bus stop hindering pedestrian

10.	Signages	Some informatory signages understandable location maps are also present in study area, but are depicted in regional language.
11.	Bus Stops	Bus-stops have no ramps and no proper space for disabled to sit or stand. Absence of information regarding buses rather it is used more for advertising purposes.

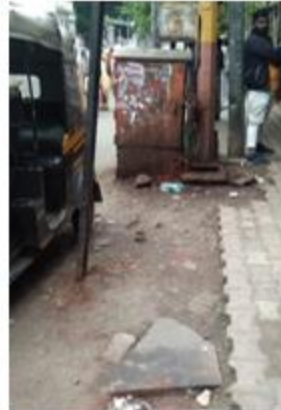
Photo 13 Broken Footpath on Shivaji Road

Indicators of Universal Accessibility	Suggestions
Safety	<ul style="list-style-type: none"> • Bollards across the footpath • Railings along ramps for climbing up and down the bus-stop and footpath • Table-top crossing at every intersection with embedded tactile pavement • Leveled footpath with uniform pavements
Convenience	<ul style="list-style-type: none"> • Construction of footpath should be completed on time • Manholes should be covered with concrete lids • Ramps at bus-stops and at starting and ending point of footpath constructed.
Connectivity	<ul style="list-style-type: none"> • Continuous footpath along the streets connecting each street with one another • Edge to edge table-top crossing at intersections with clear zebra crossing.
Comfort	<ul style="list-style-type: none"> • On-street parking can be removed and width of footpath can be increased • Separate hawker's zone can be given to reduce encroachment on footpath • Embedding tactile pavement in centre of footpath and on table-top crossing

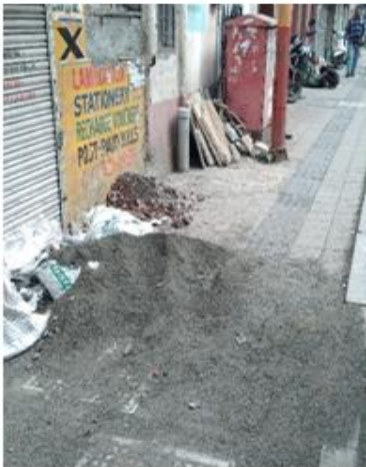
Photo 15 Construction material on footpath at Bajirao Road

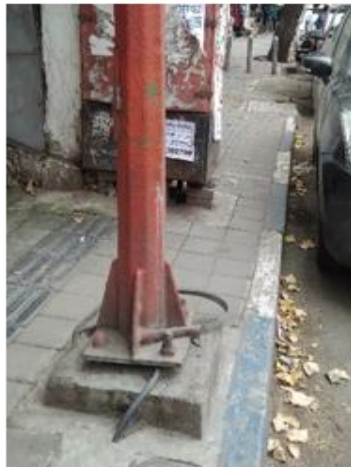
Photo 16 Electric Pole on Footpath at Bajirao Road

8.	Street Lights	Street lights on Footpath are another hindrance. The fact that this site is frequently visited by pedestrians and sometimes poor lighting makes it even more susceptible to the problems of users with cognitive disabilities.

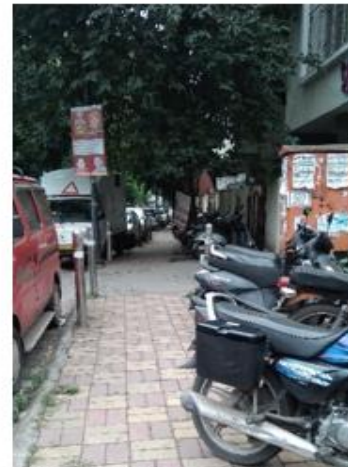
Photo 17 Illegal parking on the Footpath on bajirao Road
